Pulaski County Sewerage Authority

Sanitary Sewer Collection System Condition Assessment and Rate Analysis

July 2018

Draper Aden Associates

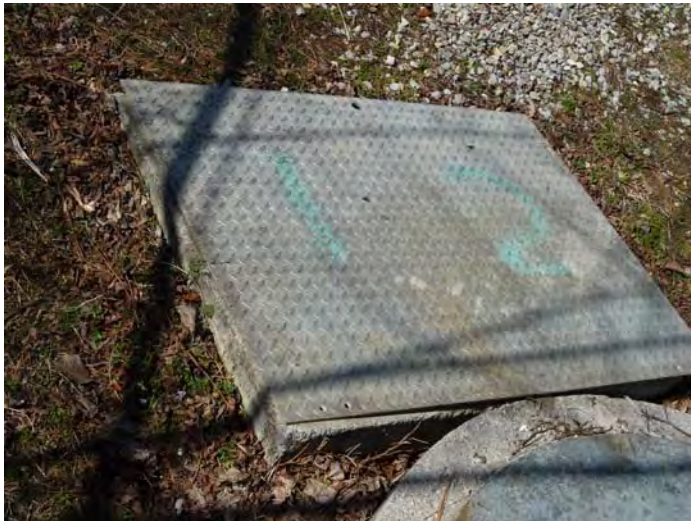
Valve Vault - Hatch

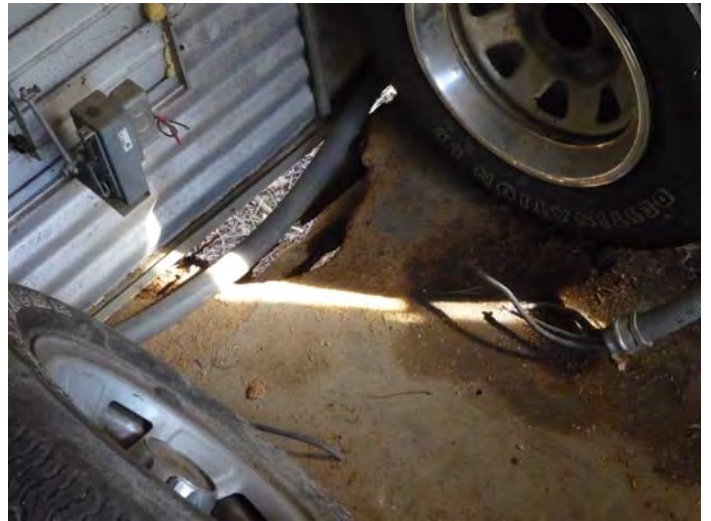
Control Building - Floor

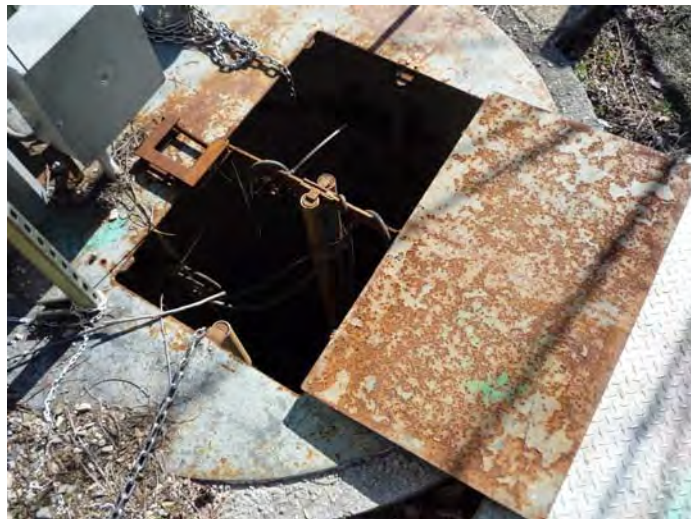
Wet Well – Hatch (Corrosion)

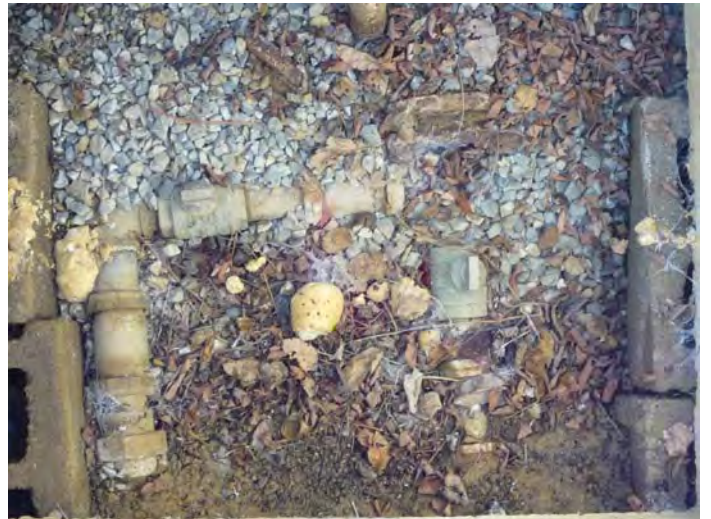
Valve Vault - Valves

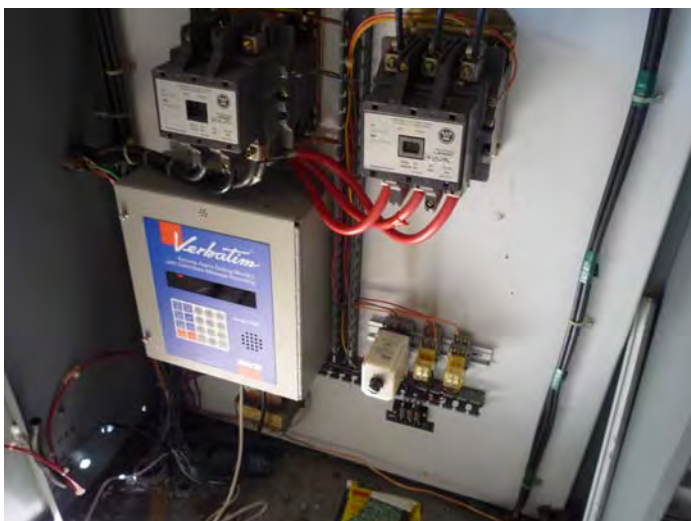
Autodialer

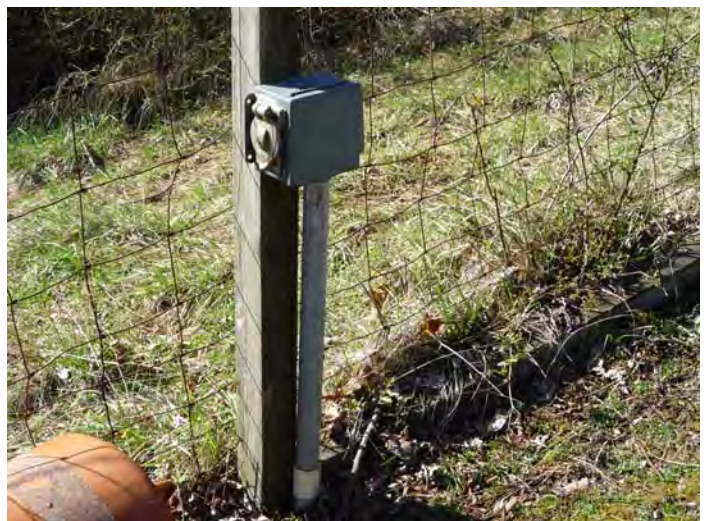
Emergency Generator Connection

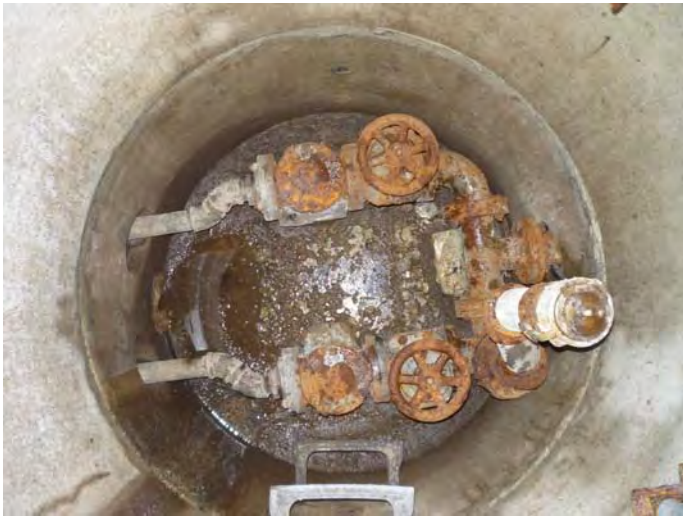
Valve Vault - Corrosion

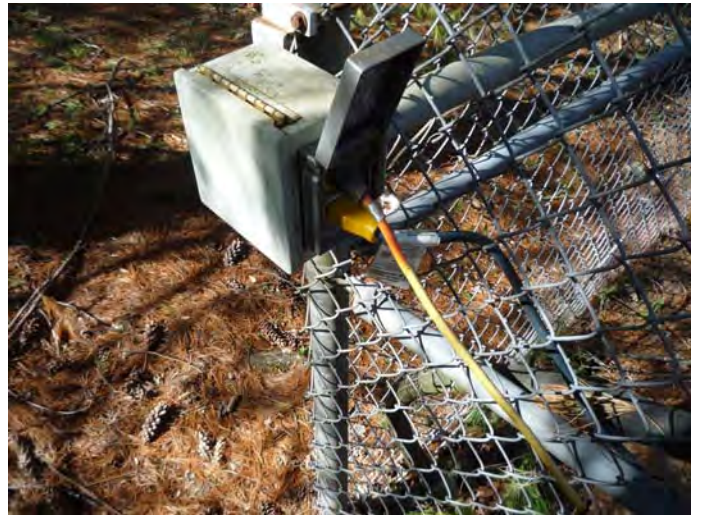
Exterior Power Cords

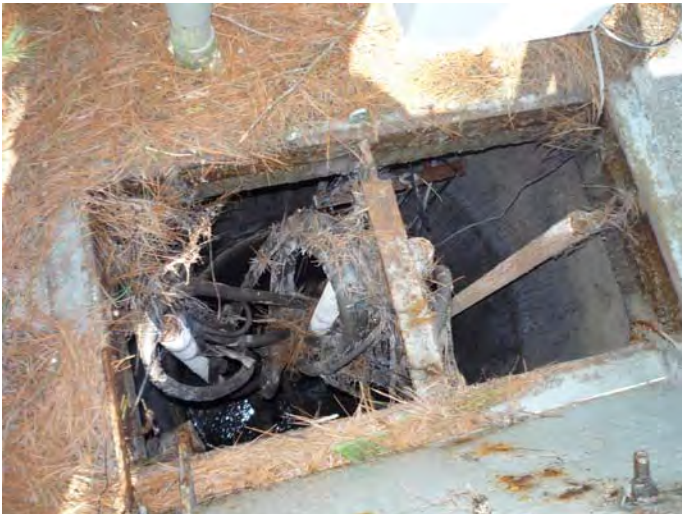
Wet Well - Debris

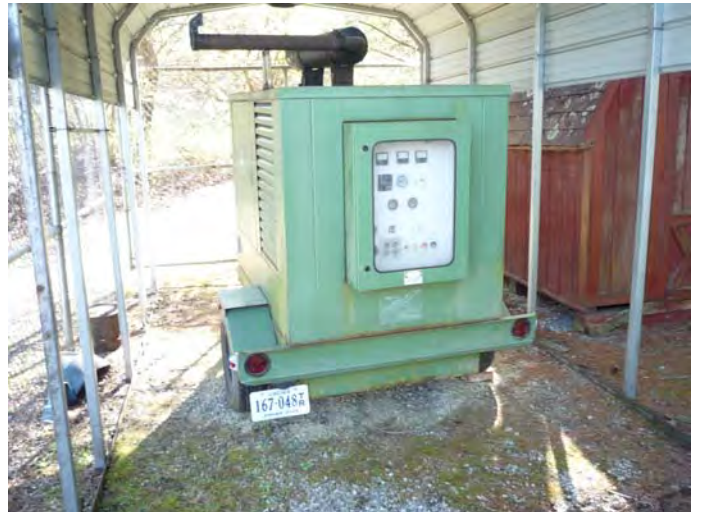
Emergency Generator

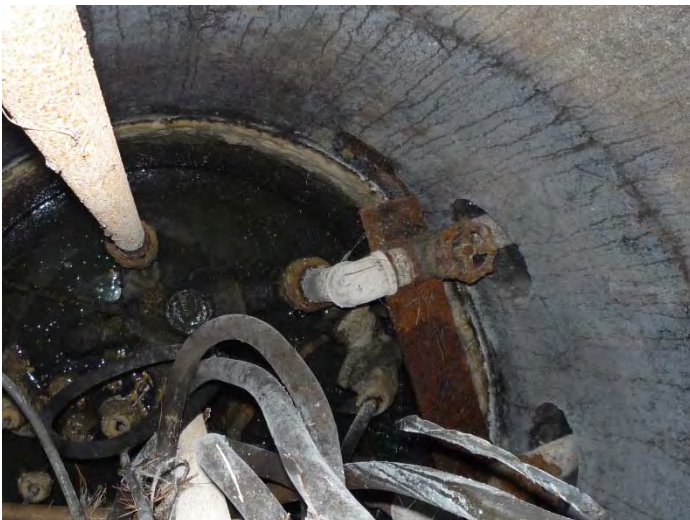
Force Main Hand Wheel

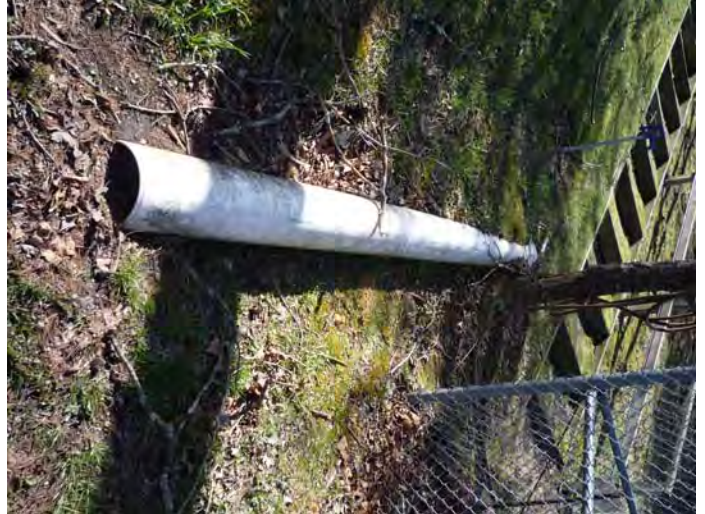
Low	Drainage Pipe is Full of Debris and Joint is Separating - This drainage pipe collects the majority of the surface flow coming off White Birch Lane and is intended to direct the flow past the pump station. It appears that the pipe is nearly full of sediment and one of the joints is separating. As the flow continues to collect in this pipe and discharge through the joint, surface water from this area will flow towards the pump station becoming a possible source of inflow.	Replace or clean drainage pipe	\$1,000
Total:			\$7,500

Drainage Conduit - Full

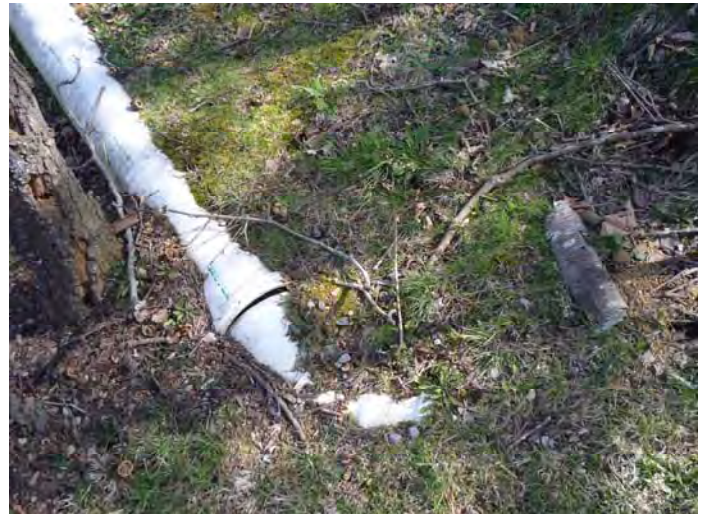
Joint Separation

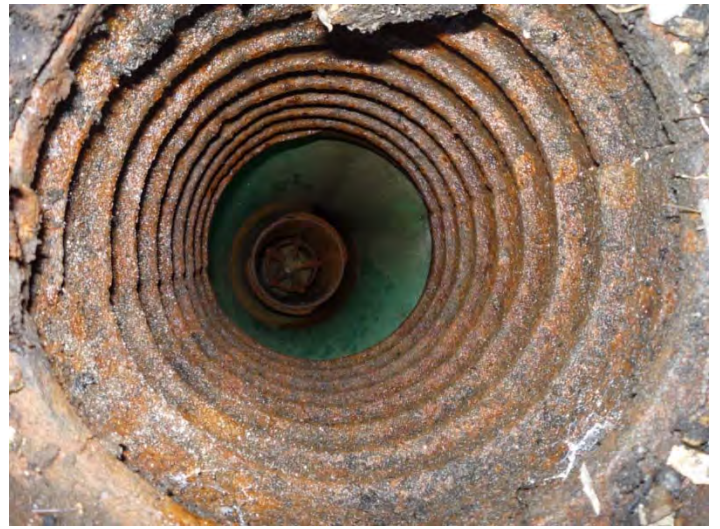
Low	Deep Installation Hand Valve - This valve will require a special extension operator and will be more likely to break than a traditional square nut operator.	Replace valve	\$2,000
Low	Missing Post Caps and Falling Barbed Wire in Fence - Fence posts without caps can collect rainwater and cause rust and degradation to the fence shortening its usable life.	Install fence post caps and reattach falling barbed wire	\$500
Low	Concrete Section Between Lift Station and Valve Vault is being Undermined - The soil is eroding away beneath the concrete in this section, which may lead to a failure in the concrete section.	Repair/replace concrete section	\$2,000
Total:			\$16,000

Deep Hand Wheel Valve

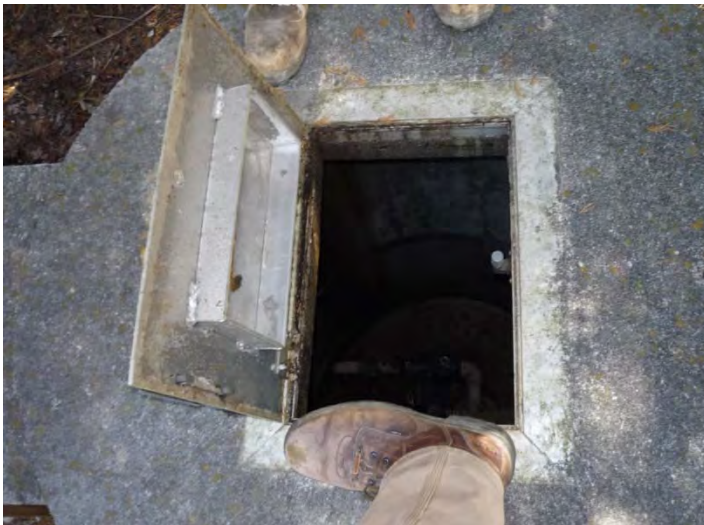
Undersized Valve Vault Hatch

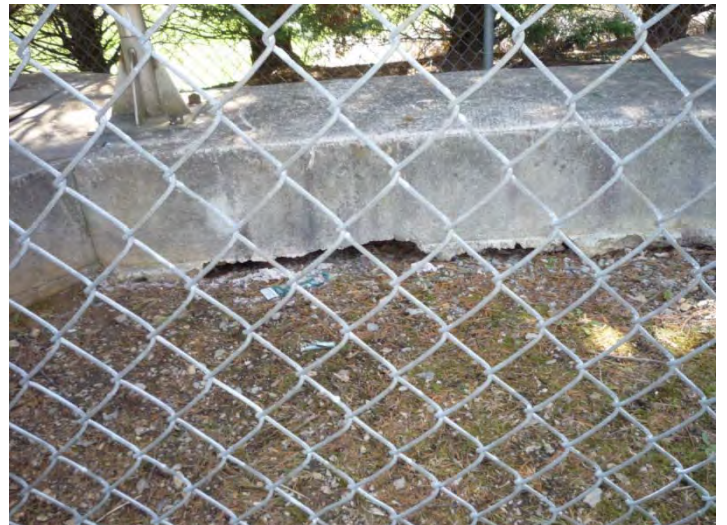
Undermined Concrete

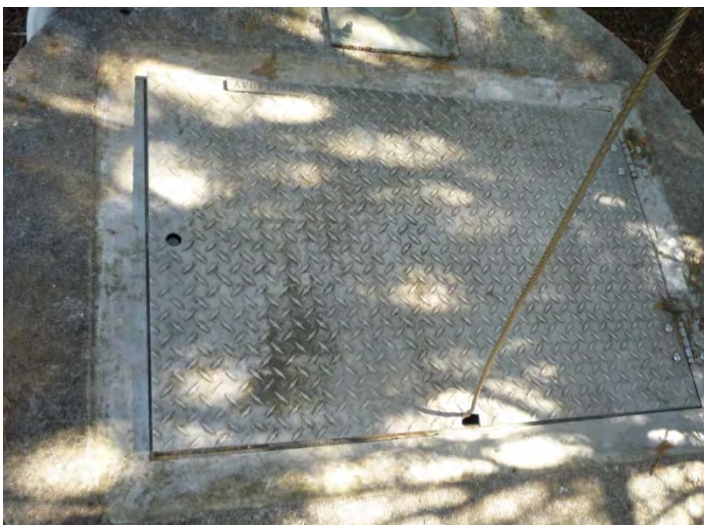
Wet Well Hatch

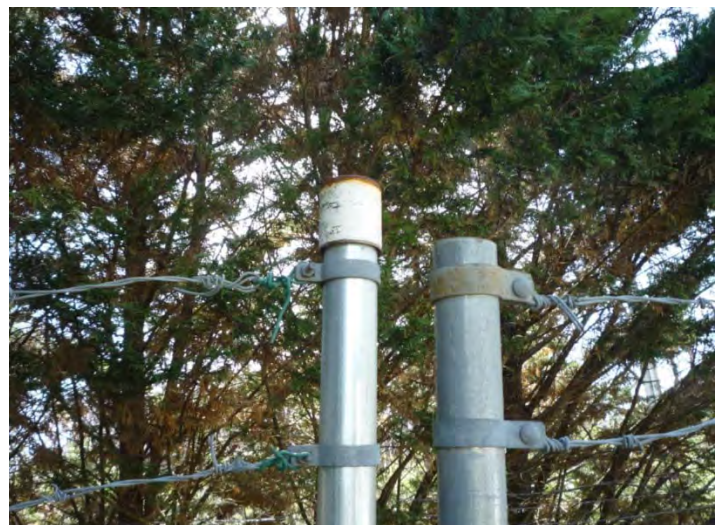
Fence Posts
