Pulaski County Sewerage Authority

Sanitary Sewer Collection System Condition Assessment and Rate Analysis

July 2018

Draper Aden Associates

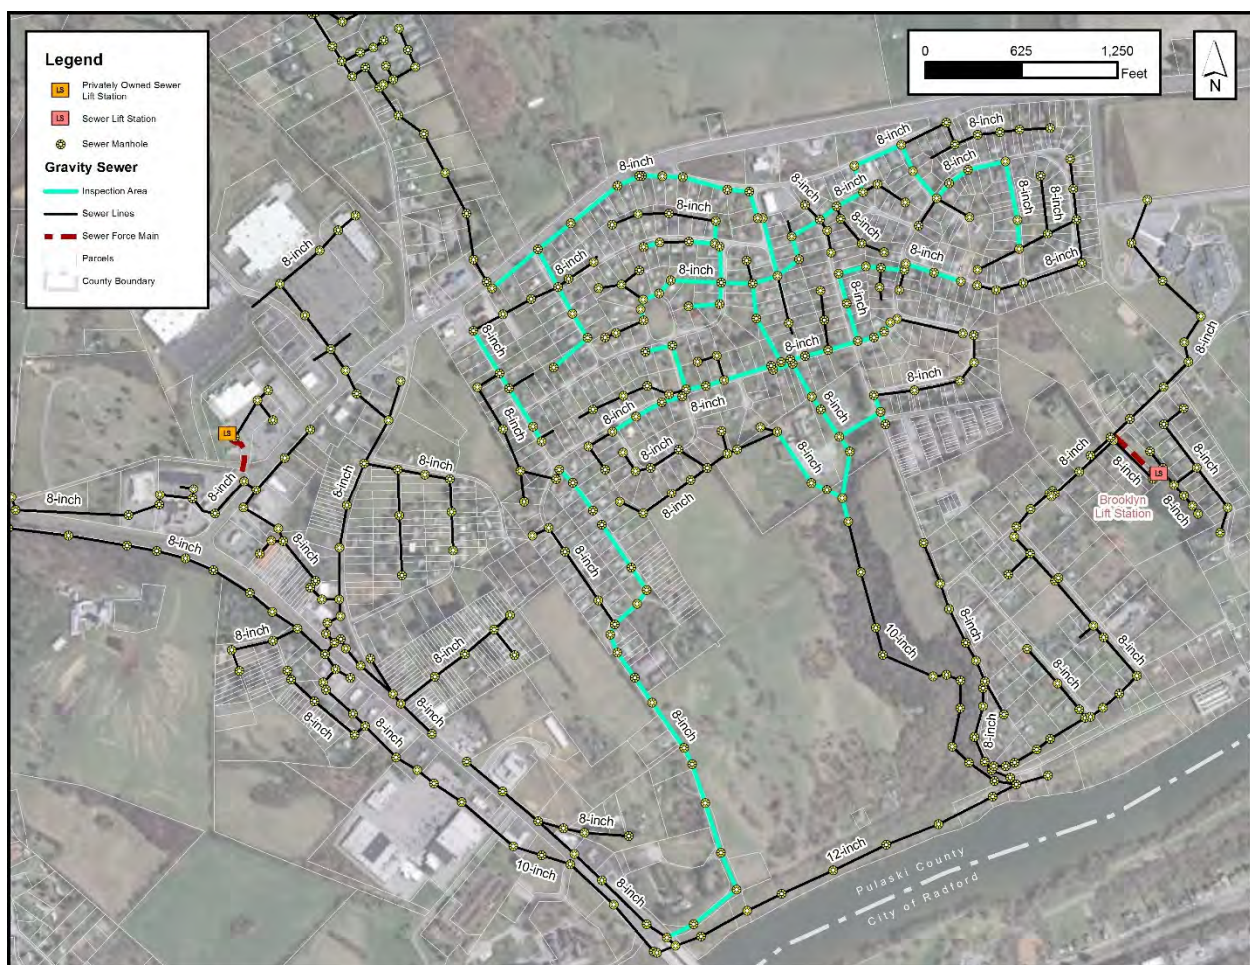
Figure 2-1: PCSA Collection System Inspection Overview

Draper Aden Associates (DAA) teamed with RedZone Robotics (RedZone) to perform the closed-circuit television (CCTV) inspection of approximately 14,000 LF of the PCSA collection system. Figure 2-1 below depicts the portion of the collection system that was targeted for inspection – This targeted area contains some of the older lines within the system and was therefore assumed to have the highest risk of failure.

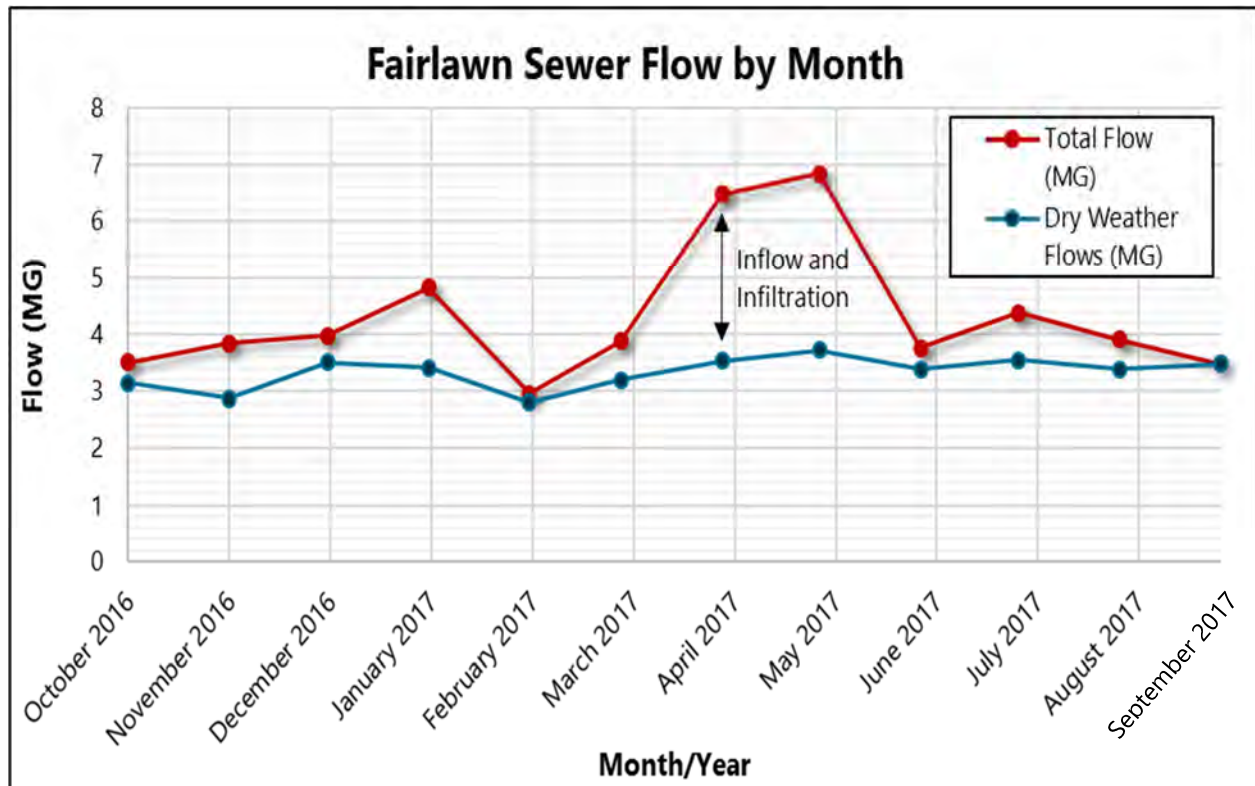
Figure 4-1: Comparison of Dry Weather and Overall Totalized Flows

As can be seen in the figure above, the majority of the I/I that entered the PCSA collection system occurred during the months of March through June. This seems logical as it correlates with the spring, which is typically the wettest period of the year.

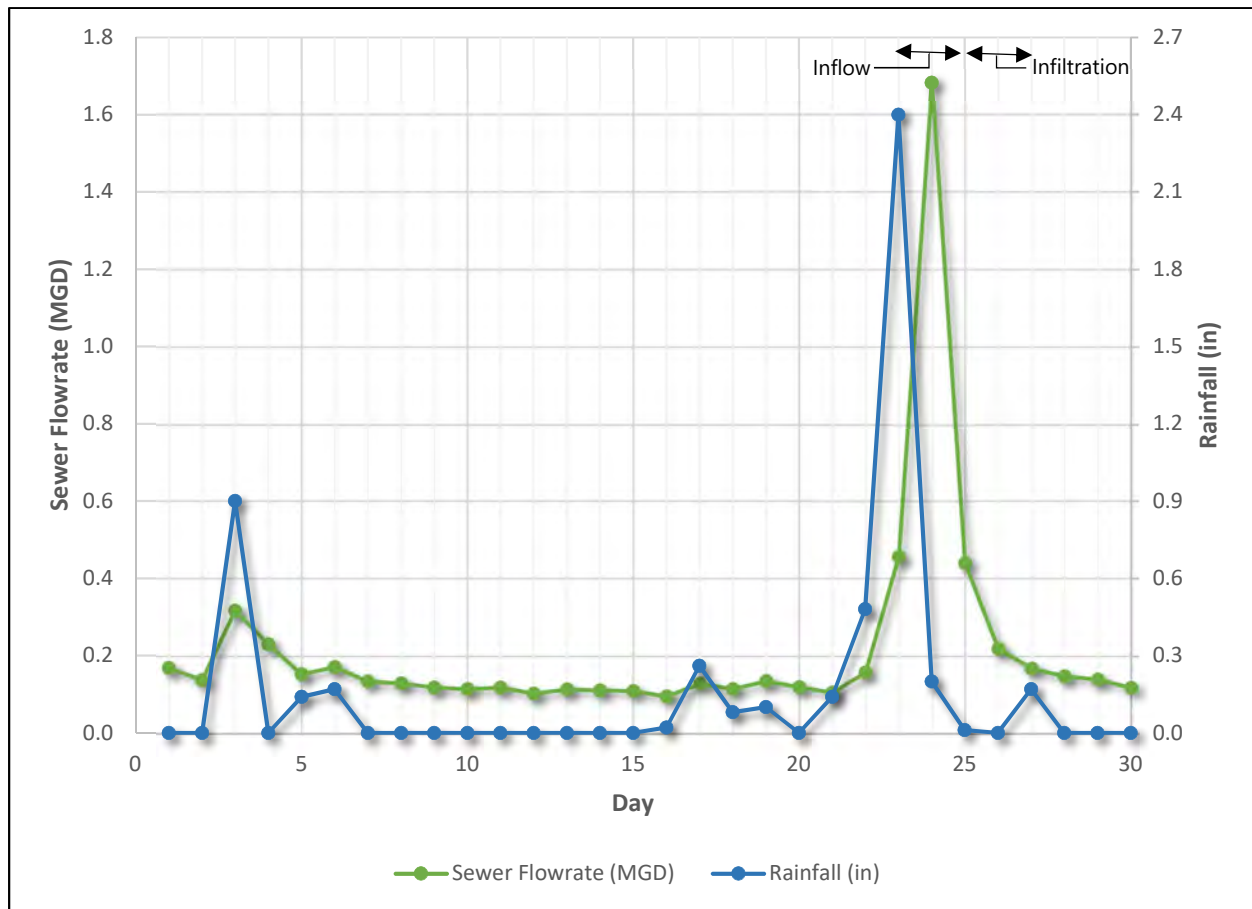
Figure 4-2: Sewer Flow Response to April 2017 Rain Event

As can be seen above, the larger the rainfall event, the larger the corresponding sewer flow peaking factor. This typically suggests that there are likely multiple sources of inflow (i.e. surface water that enters the sanitary sewer system through manhole covers, roof drains, storm drains, and other direct channels); however, when analyzing the daily flow and rainfall charts in **Appendix H**, which detail the sewer flow response to each rainfall event, it is clear that infiltration (i.e., groundwater that enters the sanitary sewer system through cracks, joints, lateral connections, and other underground defects) is also a contributor to the overall I/I. Figure 4-2 on the following page breaks down the potential I/I sources based on the system's response to a rain event that occurred on April 23, 2017, which had a total rainfall accumulation of 2.4 inches.

As indicated above, the immediate sewer response following the rain event is primarily attributed to sources of inflow. The delay in returning to normal dry weather flows is then likely attributed to sources of infiltration. Sources of inflow are more easily identifiable and are the least costly to rehabilitate as they often can be addressed with a single point repair. Sources of infiltration, on the other hand, are typically systemic as they are a function of system age and pipe material.

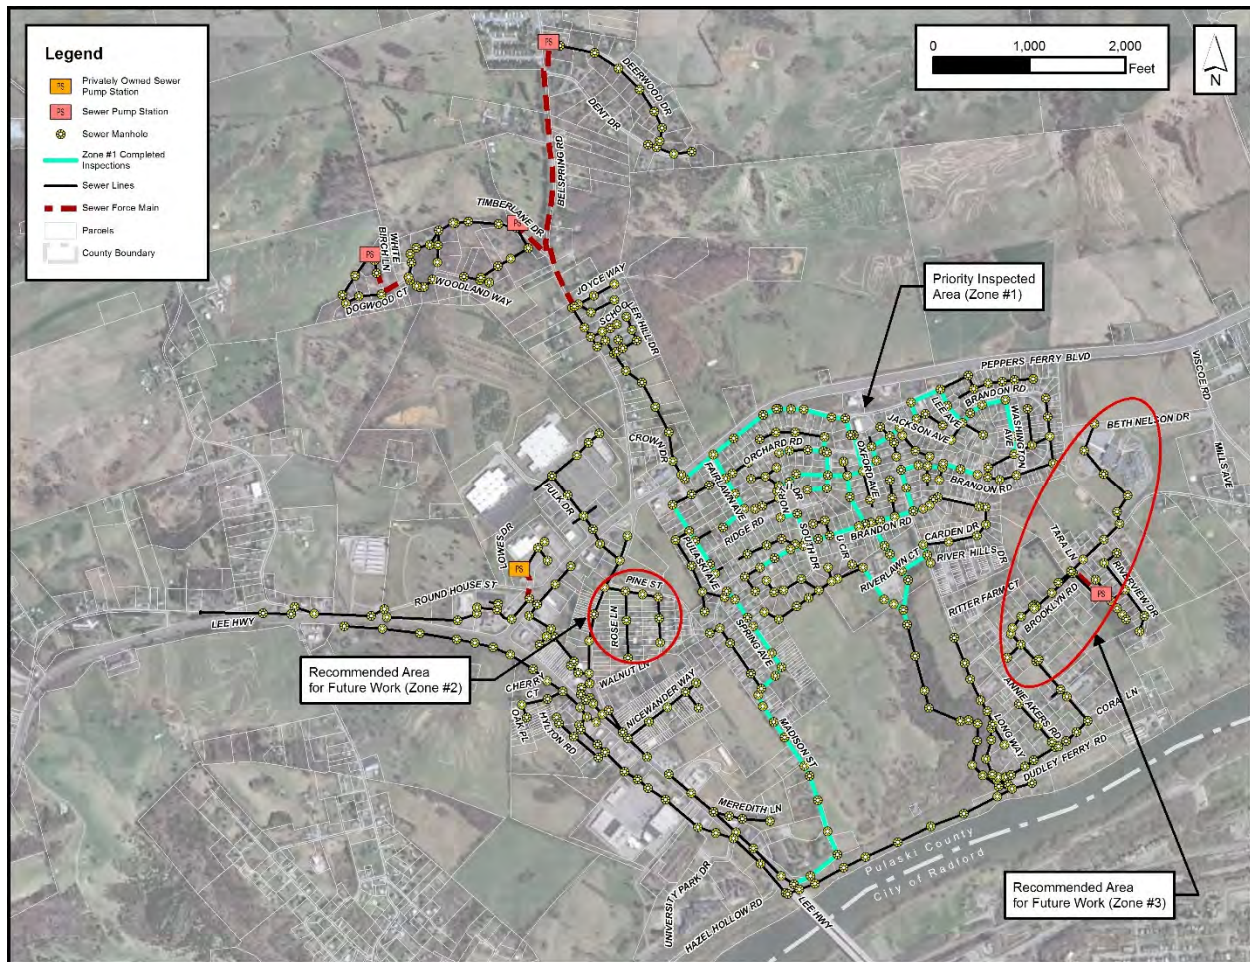
Figure 6-1: Future Work Phases

Figure 6-1 on the following page highlights two (2) areas of the gravity collection system (i.e., phases) that have been identified by PCSA as areas of focus for the next inspection phases. The inspection area completed under this report has been considered to be Phase 1.

While pipe rehabilitation will assist with reducing I/I, flow monitoring data suggests that inflow is likely a larger contributor to the system due to the immediate response time of increased flow during rain events. PCSA would benefit from ensuring that inflow is controlled by replacing manhole frames and covers to ensure they are watertight, ensuring roof and storm drains are not connected to the system, and replace cleanout caps. These replacements will supplement the effect of the rehabilitation and repairs to reduce I/I in the system.

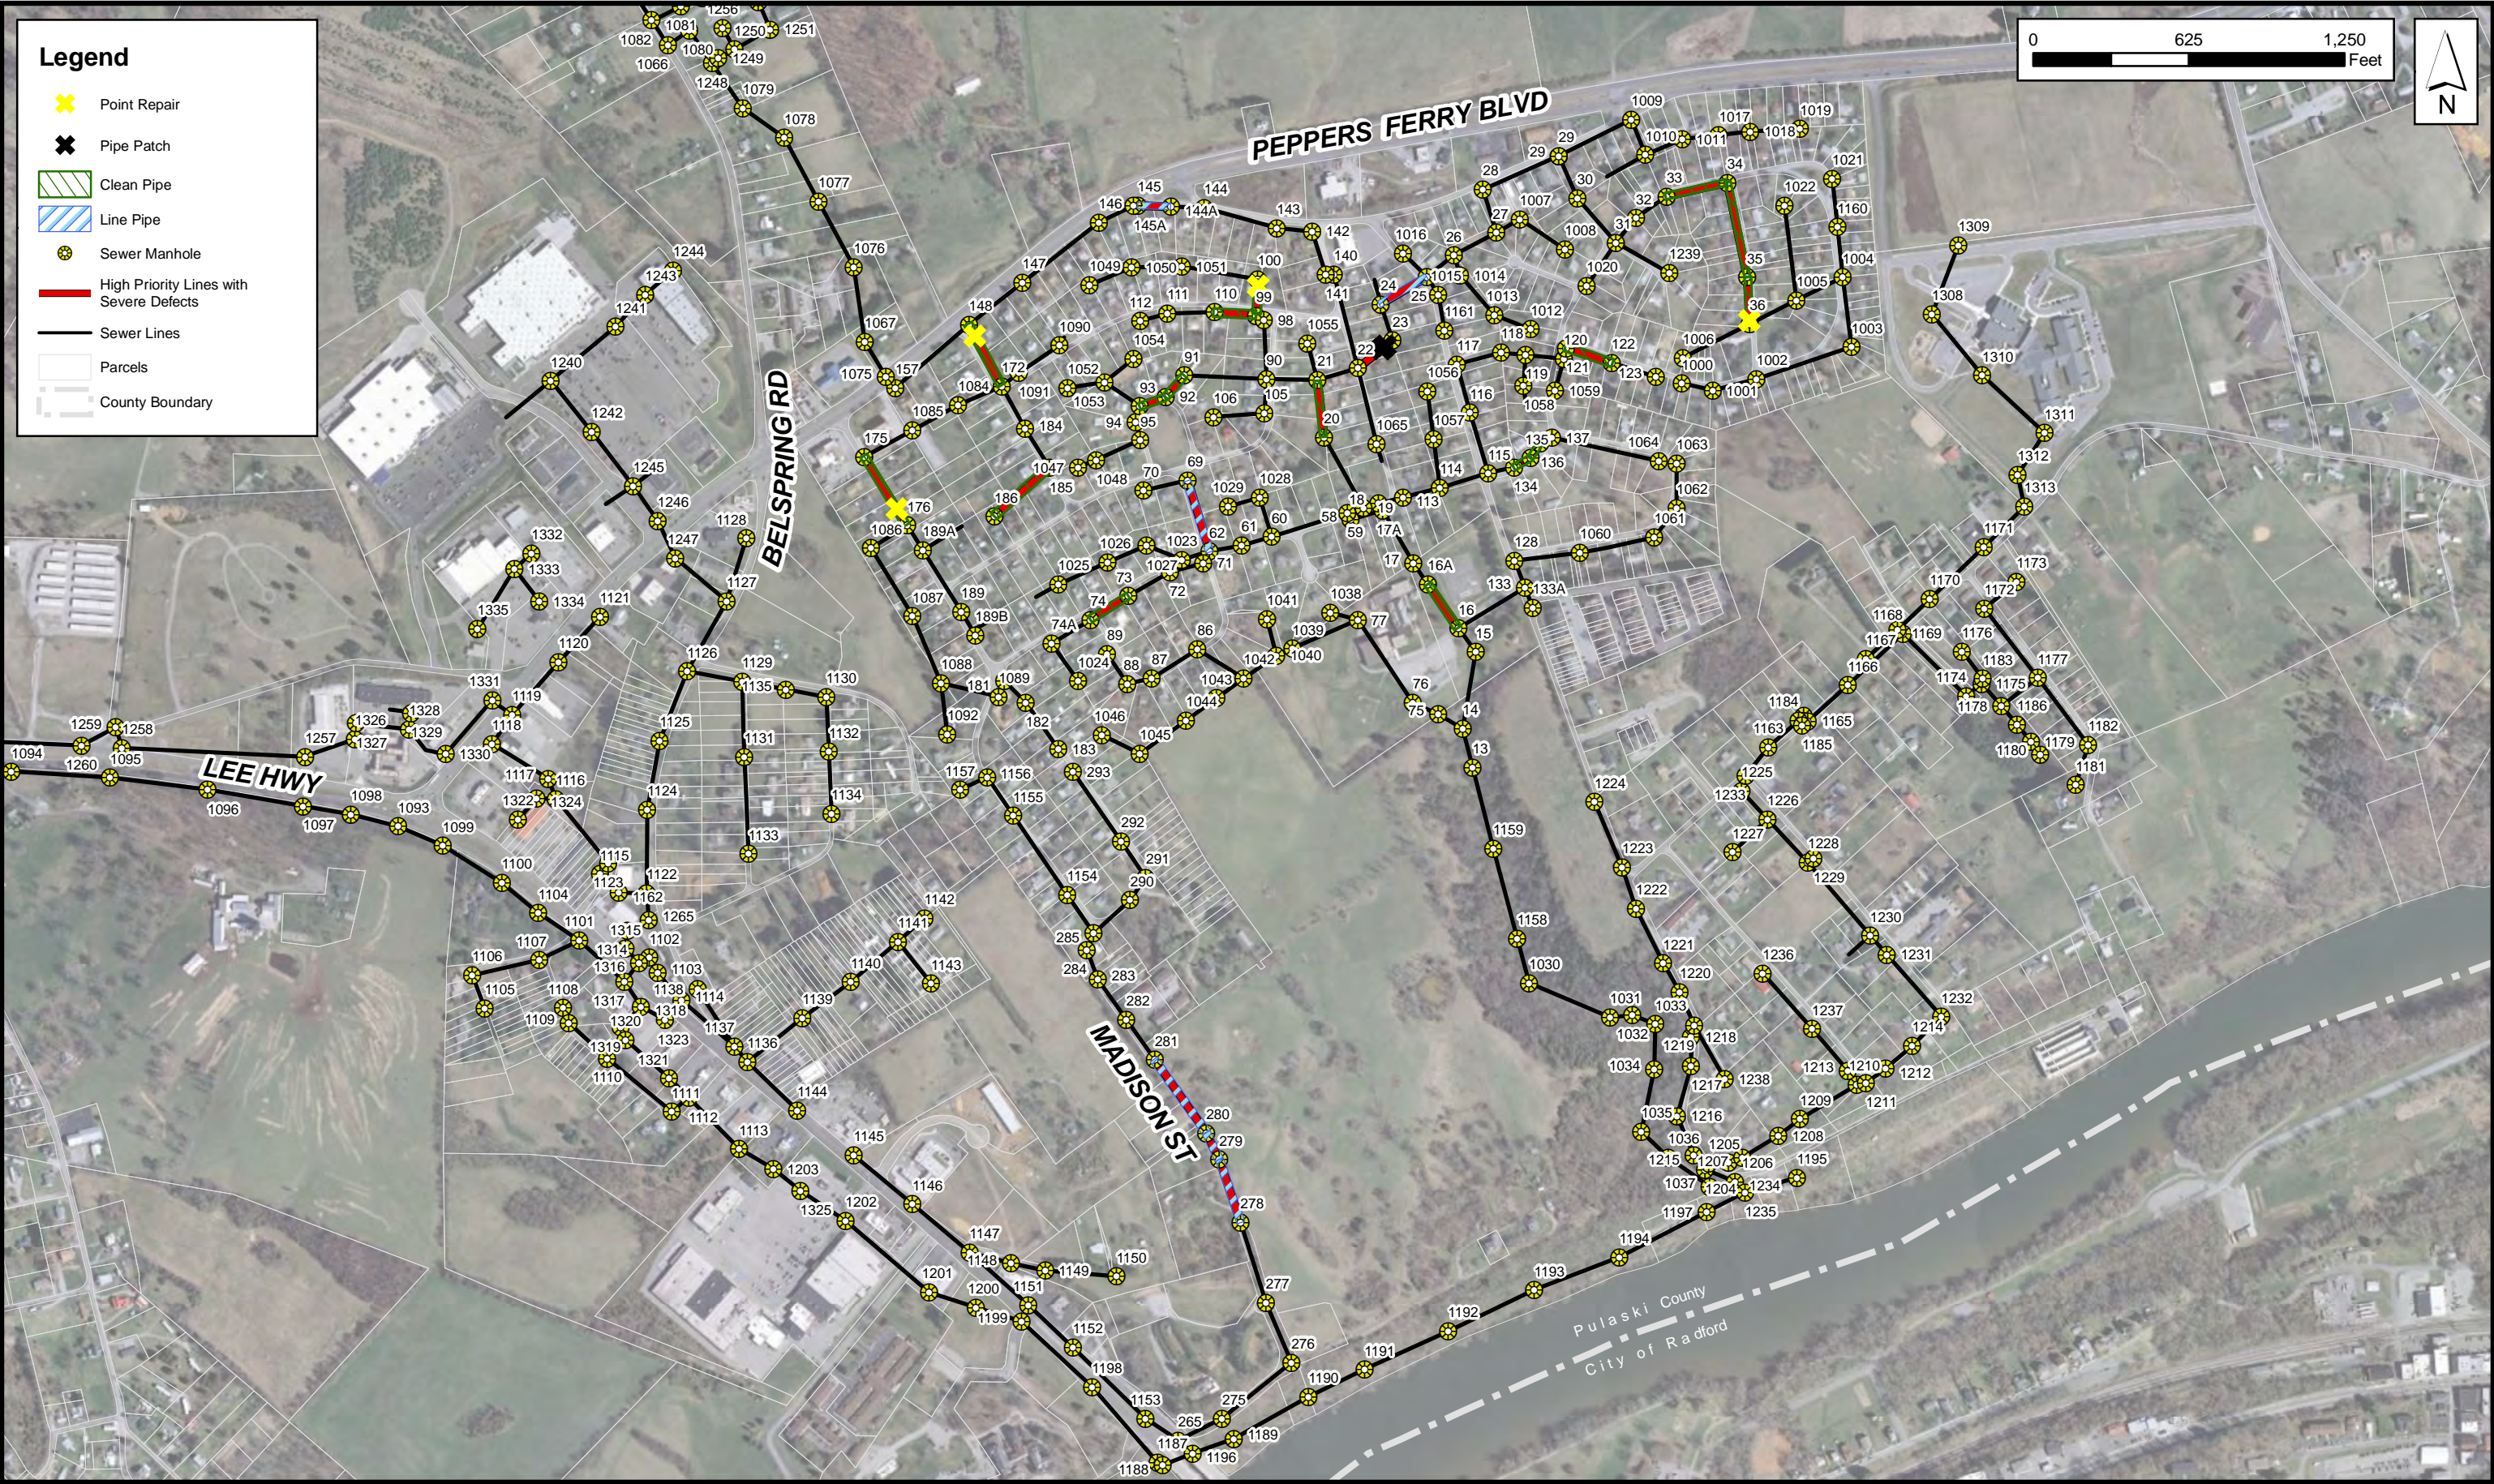
High Priority Rehabilitation and
Maintenance Recommendations (Map)

As previously noted, DAA has identified 26 sewer lines that contain severe defects and require immediate attention - A breakdown of the recommended high priority improvements and/or required maintenance is detailed below⁴:

- Cleaning and/or root removal: 15 sewer lines
- Rehabilitate with CIPP liner: 9 sewer lines (1,680 LF)
- Repair with either an internal pipe patch, point repair, or section repair: 6 sewer lines (2 Pipe Patches and 5 Point Repairs)

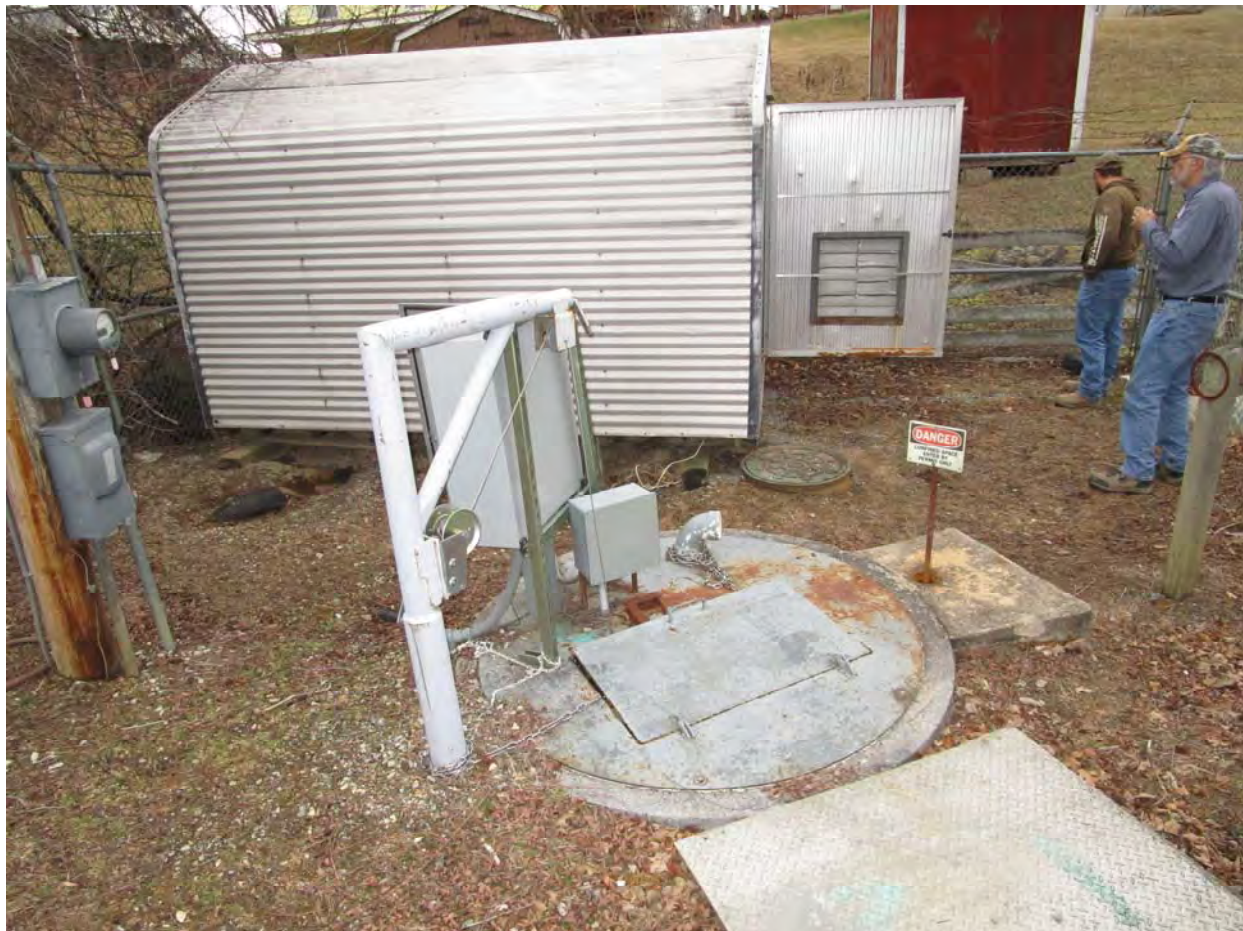
Deficiency	Priority	Probable Cost (Non-Bid)
Missing Hinge and Latch – Valve Vault Hatch	Low	\$2,500.00
Building Structure – Hole in Floor	Low	\$2,000.00
Corrosion on Wet Well Hatch	Moderate	\$2,500.00
Seepage into Pump Station Wall – Install Liner	Low	\$10,000.00
No Audible or Visual Alarm (Install Alarm Light and Speaker)	High	\$1,500.00

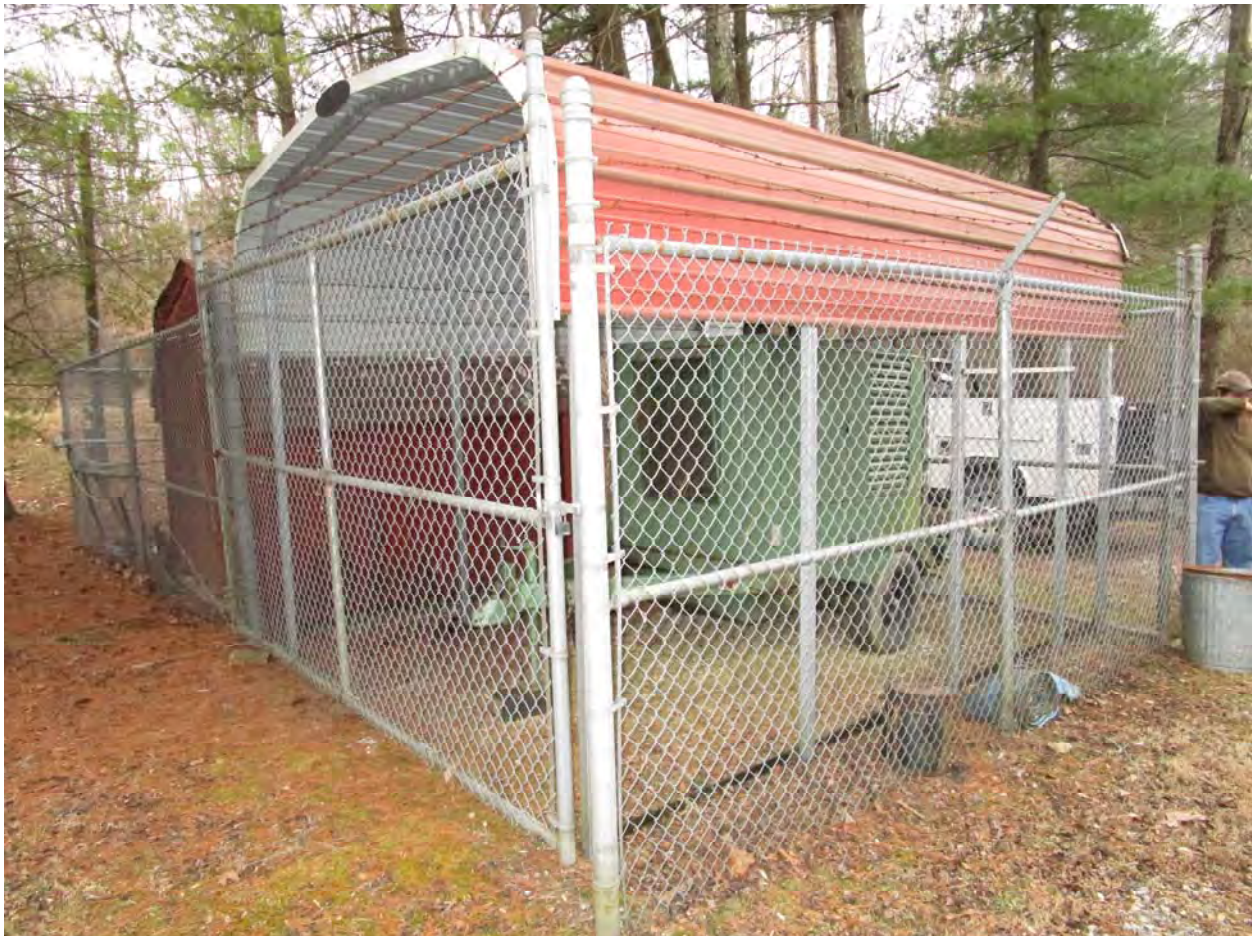
Deficiency	Priority	Probable Cost (Non-Bid)
High Corrosion in Valve Vault (Replace Valves – Seal Pipe Penetrations from H2S)	High	\$12,000.00
Exposed Power Cords (Relocate – Conduit)	Moderate	\$300.00
Overgrown Pine Trees (Prune/Maintain)	Low	Maintenance Cost
Emergency Generator Flat Tires (Fill/Maintain)	High	Maintenance Cost
Corroded Hand Wheels Force Main Discharge	High	\$2,500.00

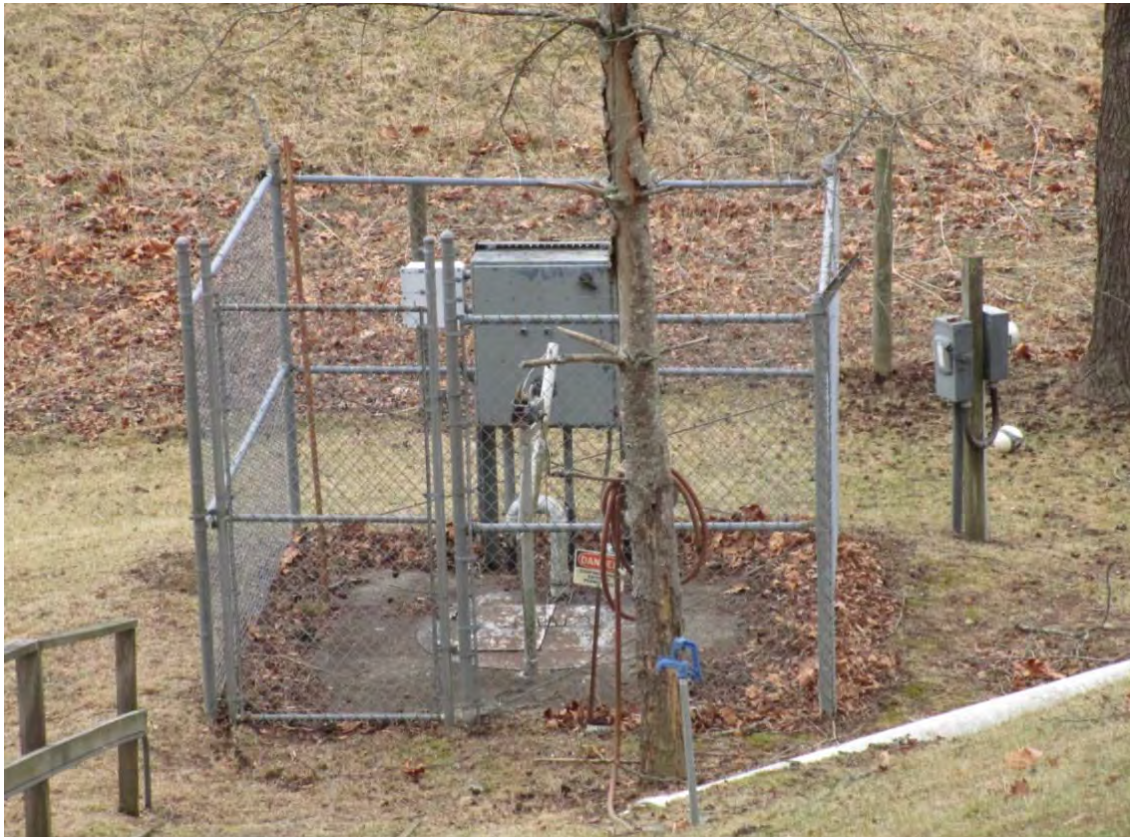
Deficiency	Priority	Probable Cost (Non-Bid)
Fence Barb Wire Falling	Low	\$200.00
Exterior Drainage Pipe Full of Debris and Joint Separation (Replace – Clean)	Moderate	\$500.00
Corrosion on Wet Well Hatch	Moderate	\$2,500.00
Electrical Disconnect Not Secured (Maintain-Lock)	High	Maintenance Cost
No Audible or Visual Alarm (Install Alarm Light and Speaker)	High	\$1,500.00
One Pump did not seem to operate as well as other (may need replacement or maintenance soon)	Moderate	\$2,000.00

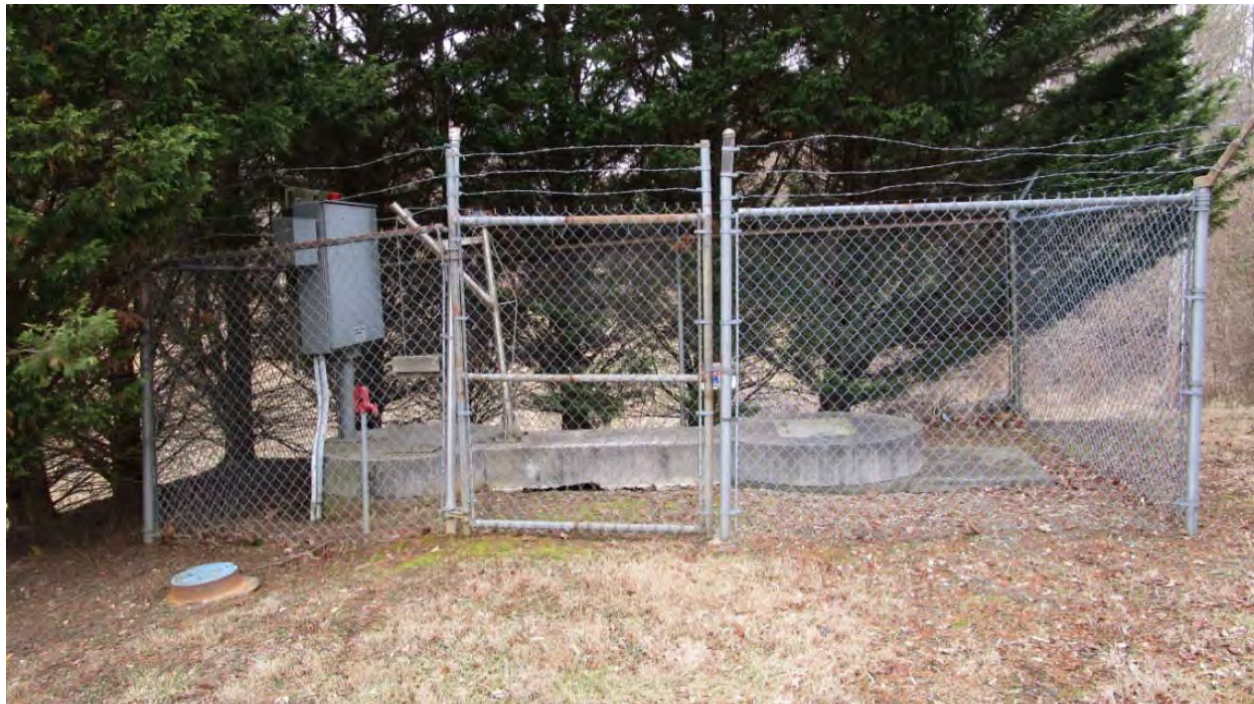
Deficiency	Priority	Probable Cost (Non-Bid)
Deep Hand Valve (Require special operator)	Low	\$2,000.00
Wetwell hatch does not close	Moderate	\$1,500.00
Fence Missing Caps – Wire Falling – (Minimal Fixes)	Low	\$500.00
Valve Vault Hatch is Undersized (replace top/hatch)	Moderate	\$3,500.00
Concrete Piece Between WW&VV is being undermined (may require replacement/removal)	Low	\$2,000.00
One Pump did not seem to operate as well as other (may need replacement or maintenance soon)	Moderate	\$2,000.00
